Manhole Inspection Summary

Manhole # S51U1_003MH

Insp Date: **10/26/08 4:40 PM**

Location Address: **Across 1870 Frankfurst Ave.**

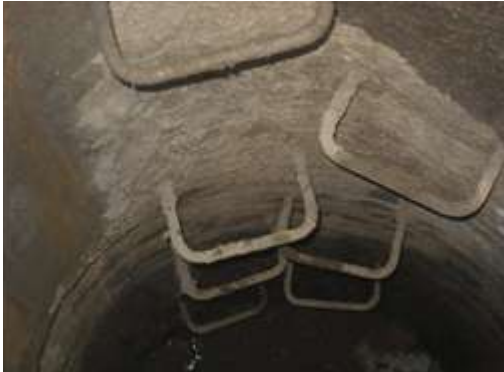
Steps

Count: **7** Missing: **0** ☐ Corroded

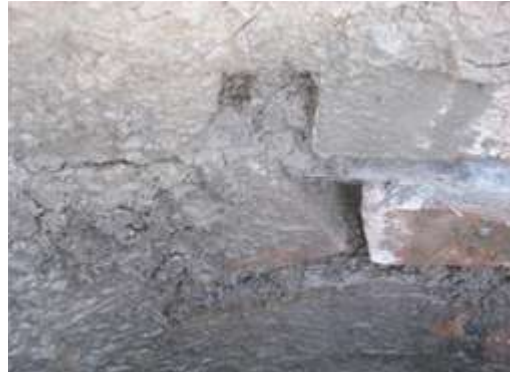
Defect 2

Condition: ☐ Sound ☒ **Cracked** ☐ Root Intrusion ☐ Loose Brick ☐ Deteriorated

Infiltration: ☐ None ☐ Joint ☒ **Cracks** ☐ Mortar ☐ Roots ☐ Wall

Cracked Barrel

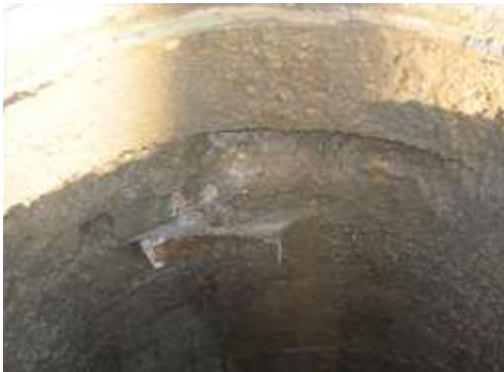
Defect 1

Condition: ☐ Sound ☒ **Cracked** ☐ Root Intrusion ☐ Loose Brick ☐ Deteriorated

Infiltration: ☐ None ☒ **Joint** ☐ Cracks ☐ Mortar ☐ Roots ☐ Wall

Cracked Joint

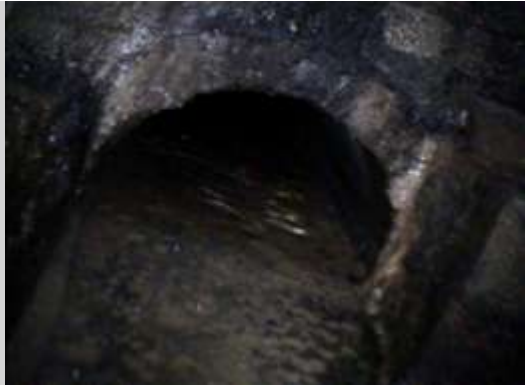
12 O'Clock Outflow

15 in. Circular Gravity Sewer
Pipe Out @ 12 O'Clock

Pipe Height: **14.4** (in.) Rod and Bar (Angled)
Pipe Material: **Clay** ☐ Pipe Lined
Invert Depth: **13.30** (ft.) Flow Characteristics: **Fast**
Deposits: ☒ None ☐ Mud ☐ Sludge ☐ Debris ☐ Grease
Silt Depth: (in.) Deposits Extent:
Infiltration: **None** Pipe Seal Cond: **Sound**

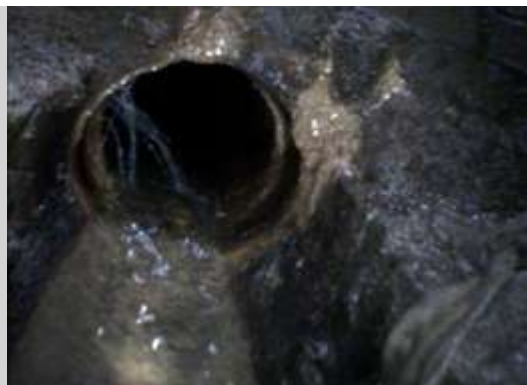
6 O'Clock Inflow

12 in. Circular Gravity Sewer
Pipe In @ 6 O'Clock

Pipe Height: **12** (in.) Rod and Bar (Angled)

Pipe Material: **Clay** ☐ Pipe Lined

Invert Depth: **13.00** (ft.) Flow Characteristics: **Fast**

Infiltration: **None** Pipe Seal Cond: **Unknown**
